Grundig Satellit 2400 Restoration (July-Oct 2025)

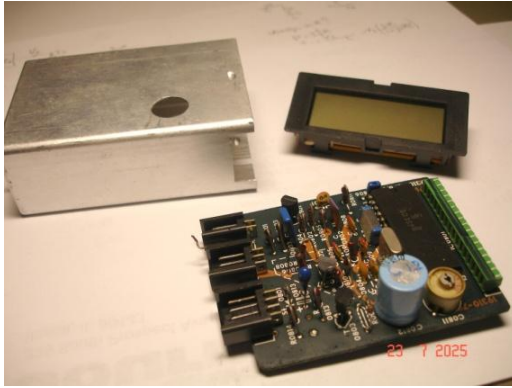
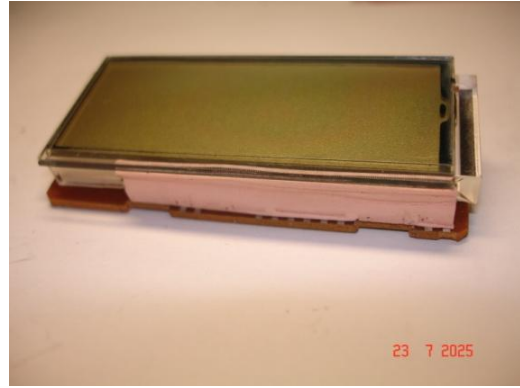
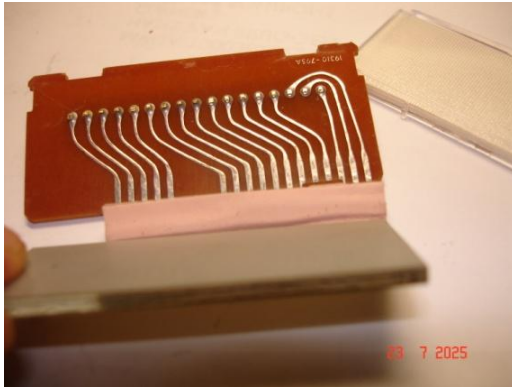
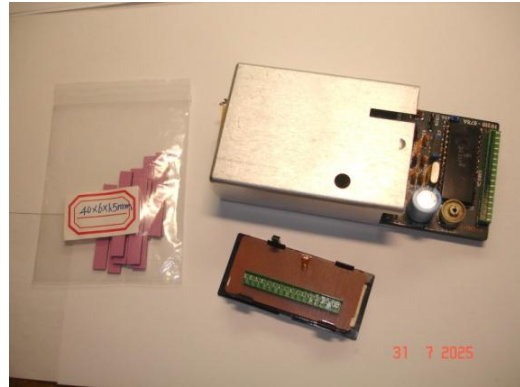
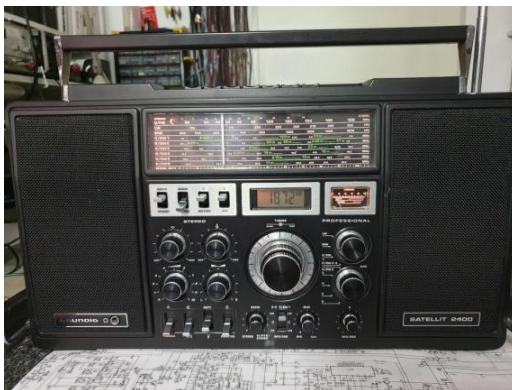
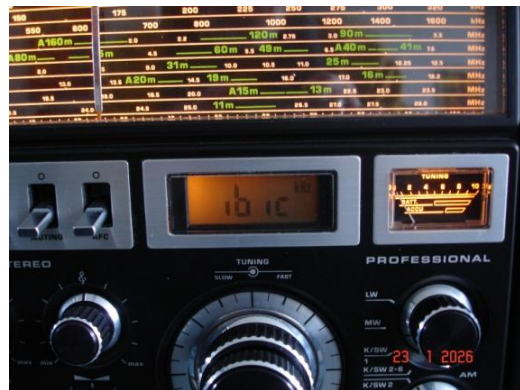
- **Failing segments of the counter-display**

Initially this problem seemed solved by replacing the rubber 'zebra strip' connector, but later the segments started dropping again. It seems that only a very very careful treatment of all the almost invisible, transparent conductive traces on the display surface, with which the zebra strip makes contact, with silver glue will fix this...

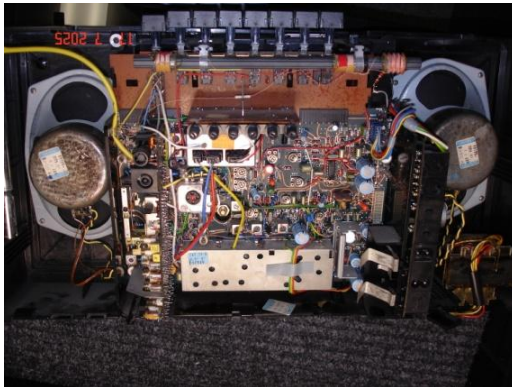
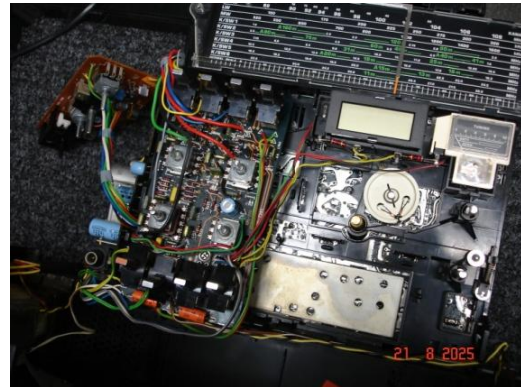
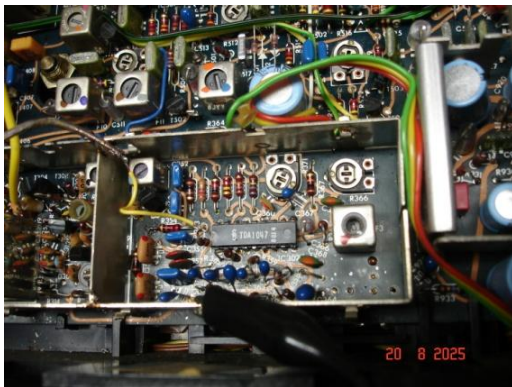
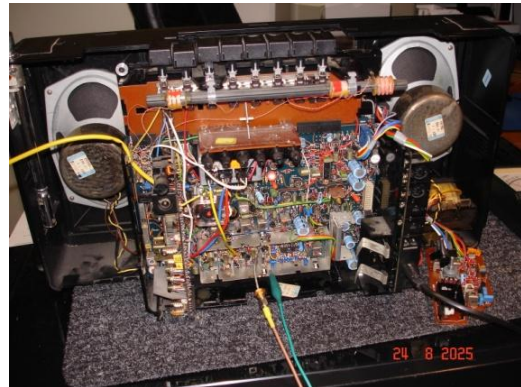
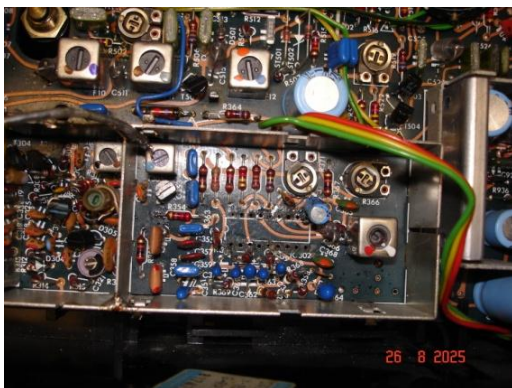
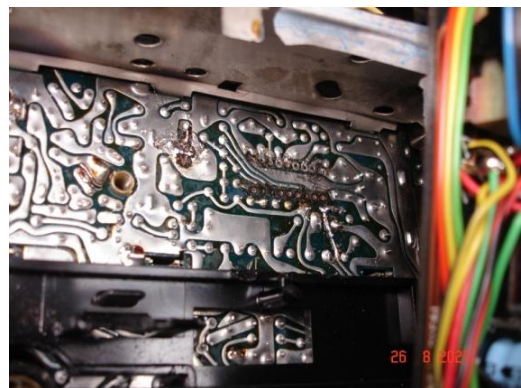
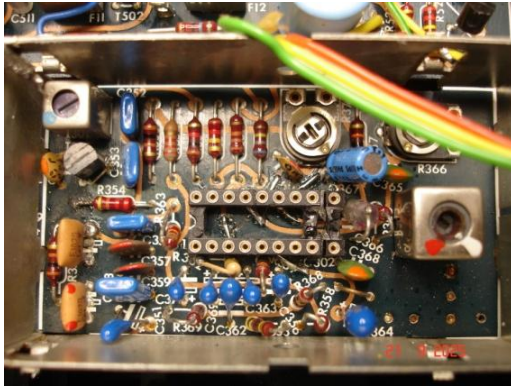
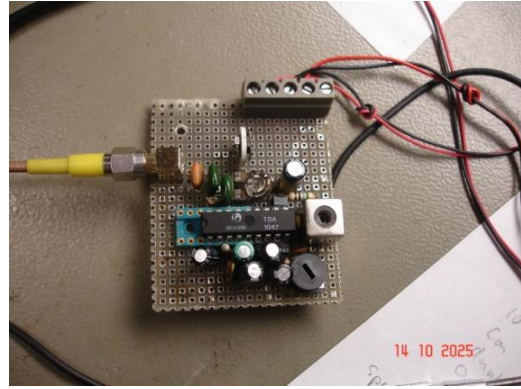
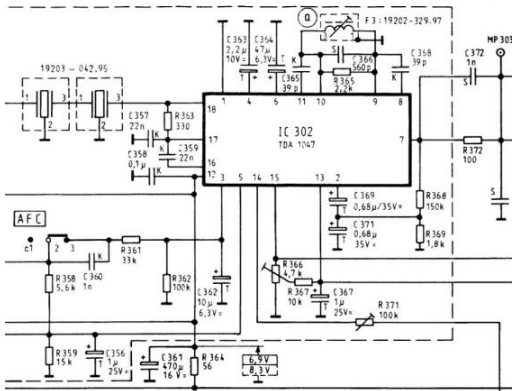
- **Poor and screeching reception on FM**

This truly was a challenge! The FM tuner is enclosed in a sturdy, soldered metal compartment, with another soldered 'lid' on the underside of the PCB. It seemed to be a problem with the FM IC, the TDA 1047, which fortunately was still available for purchase. I replaced the original IC a few times, eventually using an IC-socket, on the

PCB which by now was heavily damaged on both the top and bottom sides... I also replaced various other components, including the ceramic IF filters. It was all in vain. Eventually, I rebuilt the circuit around the TDA 1047 externally on a separate PCB and connected it. That worked well, so it had to be a problem with the components directly surrounding the TDA 1047. After much searching and trying, it eventually turned out that one of the three capacitors at the input of the TDA 1047 was the culprit; unfortunately, it is not clear which one, as all three were replaced at the same time. These are C357, C358, and C359 (see schematic diagram below). And what was wrong with them is also unclear.

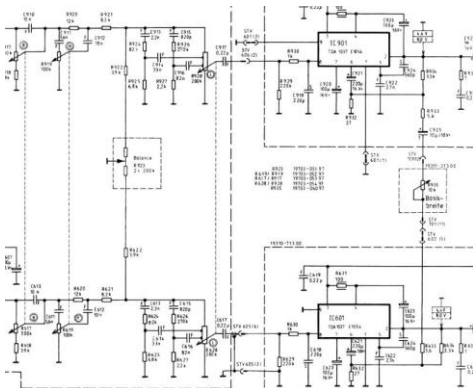
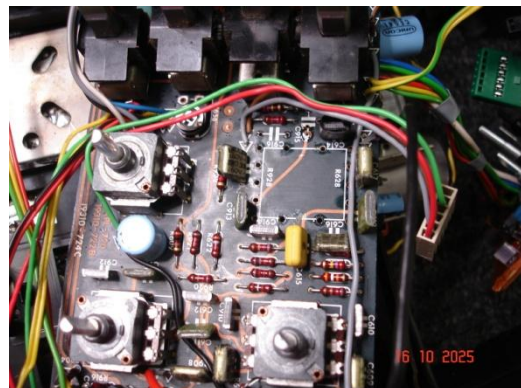
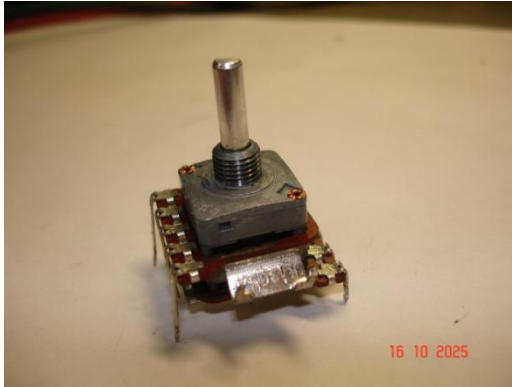
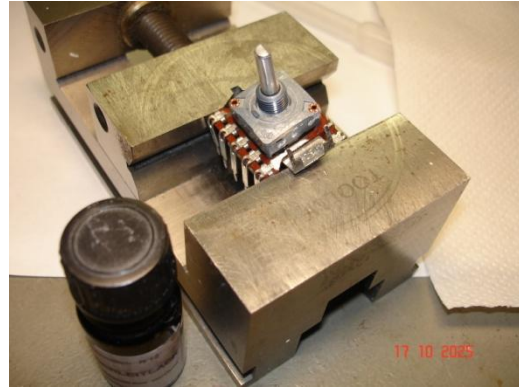
- **Difference in timbre L/R**

This ultimately turned out to be due to poorly conductive contact tracks inside the housing of the special stereo potentiometer R628/R928. This is a potentiometer with 5 connections per channel, 2 of which are fixed taps, connected to frequency-dependent networks. This causes a 'loudness' timbre effect, depending on the volume setting. The potentiometer was removed from the PCB, its metal housing was slightly bent open at the sides, and the conductivity of the relevant contact tracks at the interrupted spots was very carefully restored using silver glue.

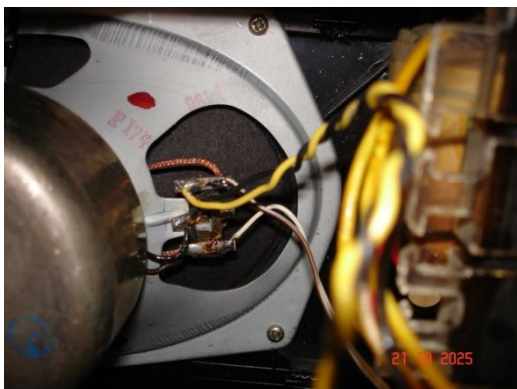
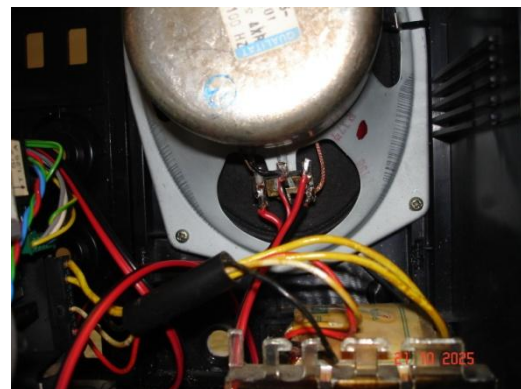
- **Difference in volume L/R**

Although this is not necessarily the main cause of the L/R volume difference, it is noteworthy that the (low-impedance) speaker combinations are connected with fairly thin wire, especially the tweeters, while there is a clear difference in length for the wires to the L and R speakers. Replaced all connections with thicker wires of equal length for L and R.

Other points of attention are, once again, the volume potentiometer, and regarding tweeter reproduction, the tweeter switch and the two 3.3 μF electrolytic capacitors C628/C928, which power the tweeters. It is still not quite right.

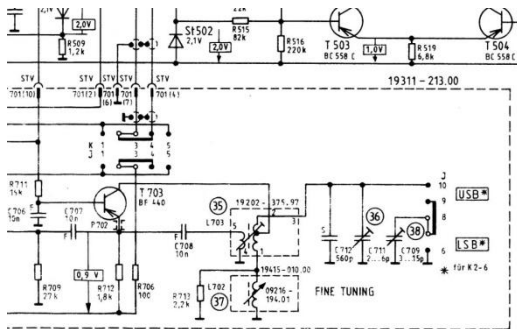
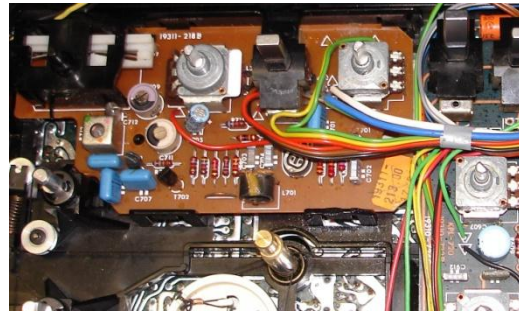
- **Difference in zero setting LSB/USB**

The BFO (Beat Frequency Oscillator) for receiving SSB (Single Side Band) signals is set by adjusting the two trimmers C709 and C711. With correct adjustment, a point of 'zero beat' can be heard at one of the two ends of the BFO/SSB control knob's range, when optimally tuned to a 'bare carrier wave' and with the BFO/SSB switch in the up or down position. With the BFO/SSB control knob set to zero, an approximately 1.5 kHz 'beat frequency' should be audible. Furthermore, with the BFO/SSB control knob

set to zero, in the absence of any signal, the received noise should sound approximately the same for the up or down positions of the BFO/SSB switch.

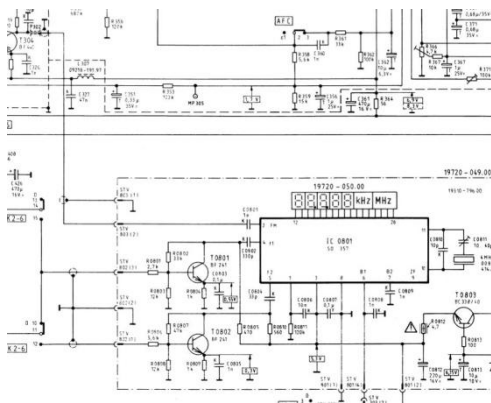
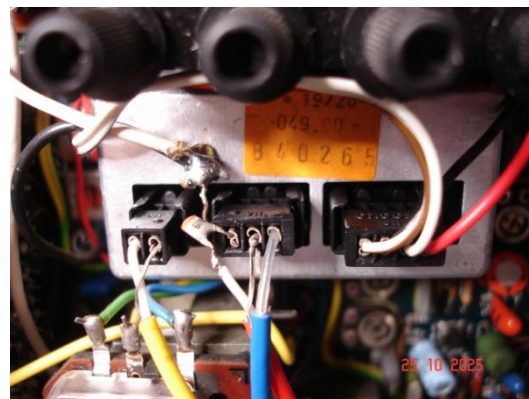
- **Counter feedback on AM tuning**

The frequency counter was found to have feedback on AM tuning when switched on, something that is only noticeable when receiving an SSB voice or morse signal. In that case, you hear a regular 'hiccup' in the sound. The solution was to couple the counter slightly less strongly to the 'local oscillator' by incorporating a small series capacitor in terminal 2 of the counter (hardly visible in the photo, but it is the small coaxial cable with the red sheath). At a value of 6.8 pF (see photo), the counter still worked well on all bands and the problem was virtually gone.

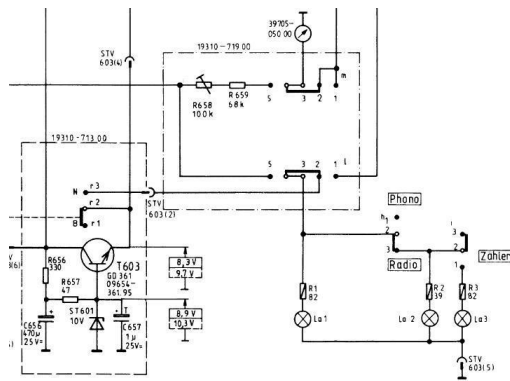
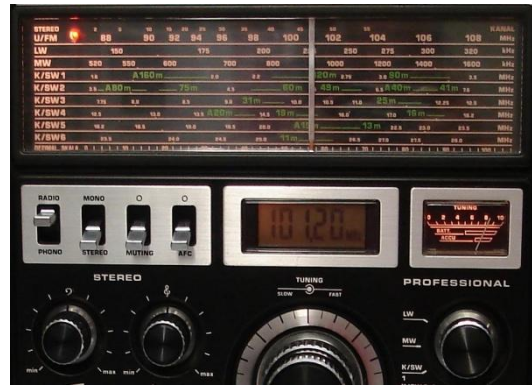
- **Sometimes a slight flickering of scale lighting**

The lights for the scale lighting and the frequency counter lighting (if switched on) sometimes flicker a little. Flipping the PHONO/RADIO switch a few times helps to stop this, but it returns after a while. The cause must be a bad contact in that switch (the connection points h2/h3 in the schematic diagram) but not really worth doing anything about. The illumination of the S-meter/battery voltage meter is unrelated to this.
