Grundig Satellit 2400 Restoration (July-Oct 2025)

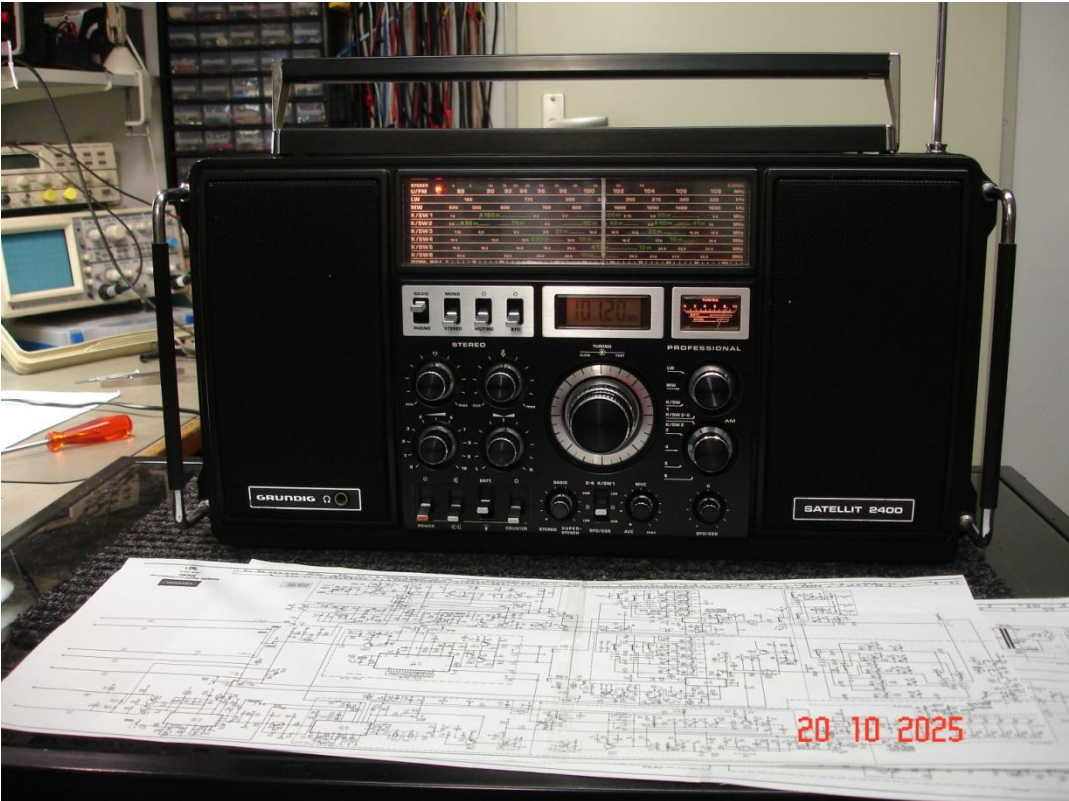
The Grundig Satellit 2400 (from approx. 1979) is nothing less than a fine work of art, combining hi-fi stereo quality FM reception with AM/SSB reception from LW to SW in multiple spread bands, supported by a digital frequency display and a coarse/fine tuning knob. It is a very ingenious, good receiver, but the designers seem to have done their best to make everything as fragile and inaccessible as possible, and to turn repair or restoration into a major undertaking...
